**GENERAL LAYOUT
OUZINKIE**

Ouzinkie City Dock

Owner: City of Ouzinkie
Contact: City of Ouzinkie – 907-680-2209

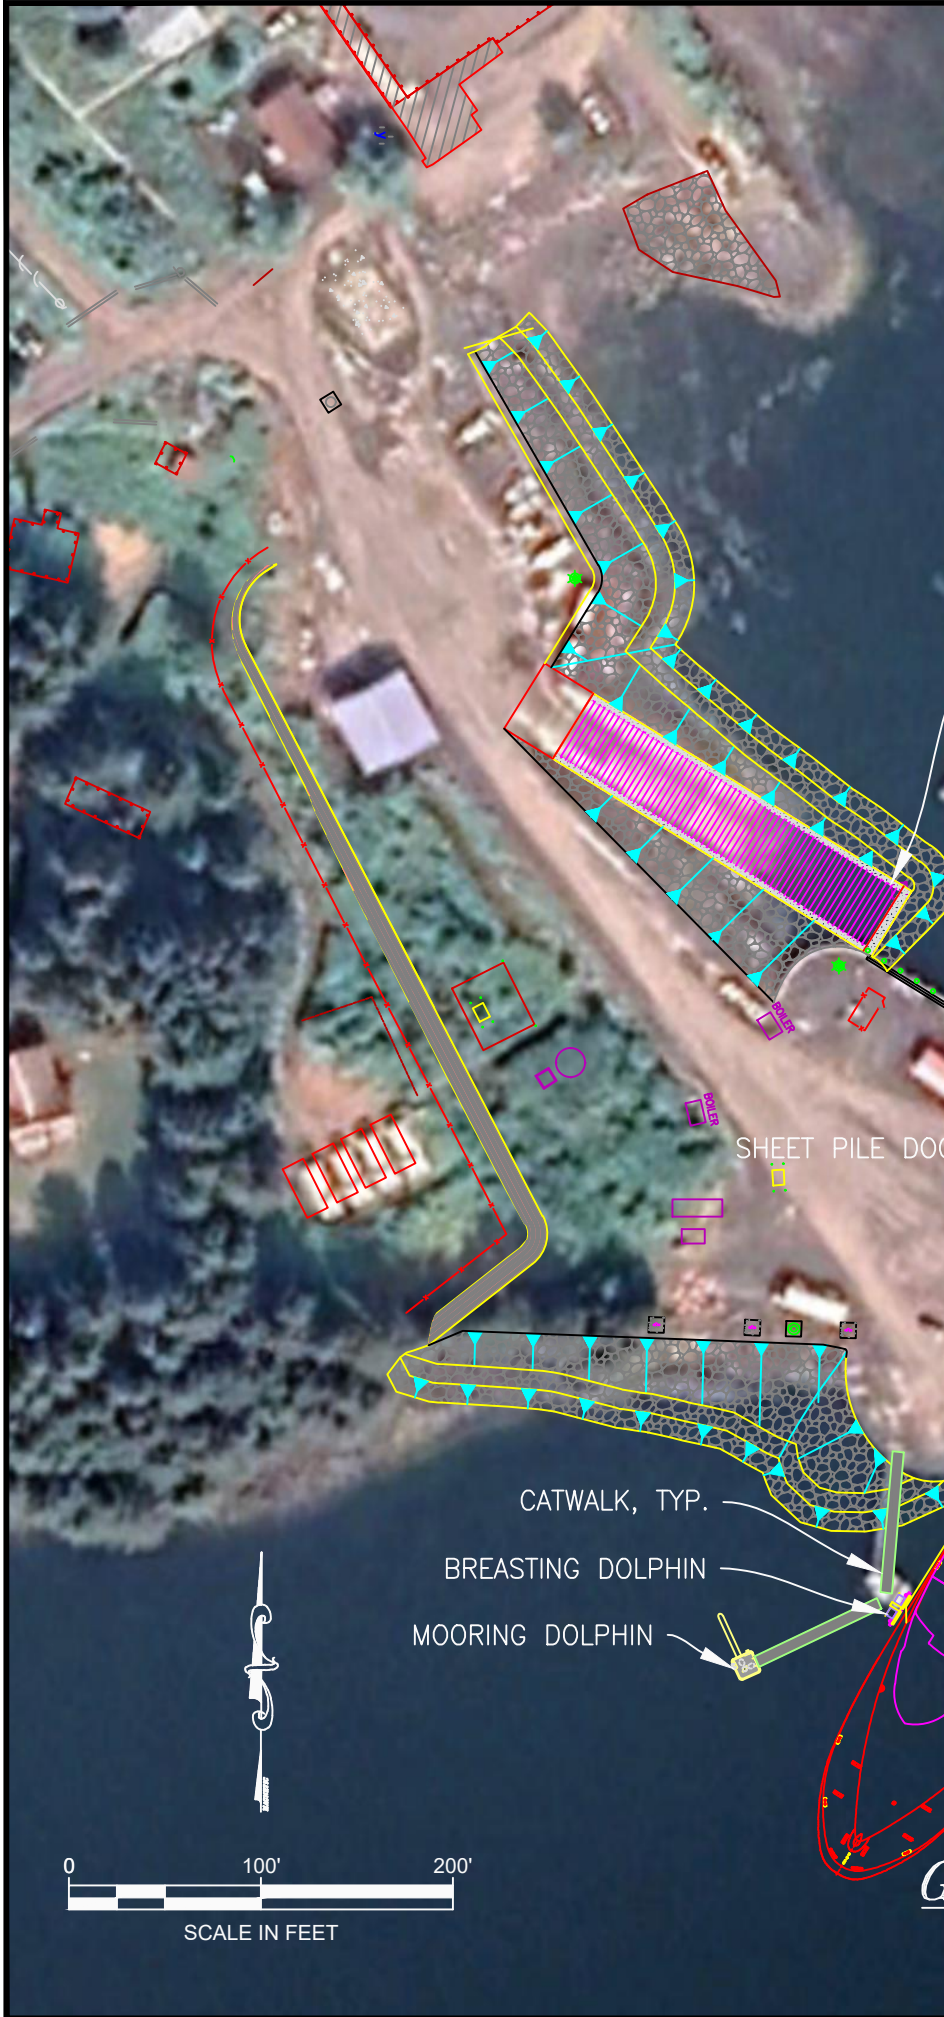
CONCRETE
BOAT RAMP

DOCK CRANE

FUEL CONNECTION

SHEET PILE DOCK

CATWALK, TYP.

BREASTING DOLPHIN

MOORING DOLPHIN
