**GENERAL LAYOUT
SOUTH MITKOF**

South Mitkof Ferry Terminal

Terminal Description: South Mitkof is a side-loading facility constructed in 2006 consisting of a modular ticketing office, secure (fenced) staging area, 900-foot long steel approach, steel transfer bridge, steel support float and six steel pile mooring dolphins. The IFA northern route has not been operational since 2008. South Mitkof's total passenger and vehicle traffic between 2006 and 2008 is shown below.

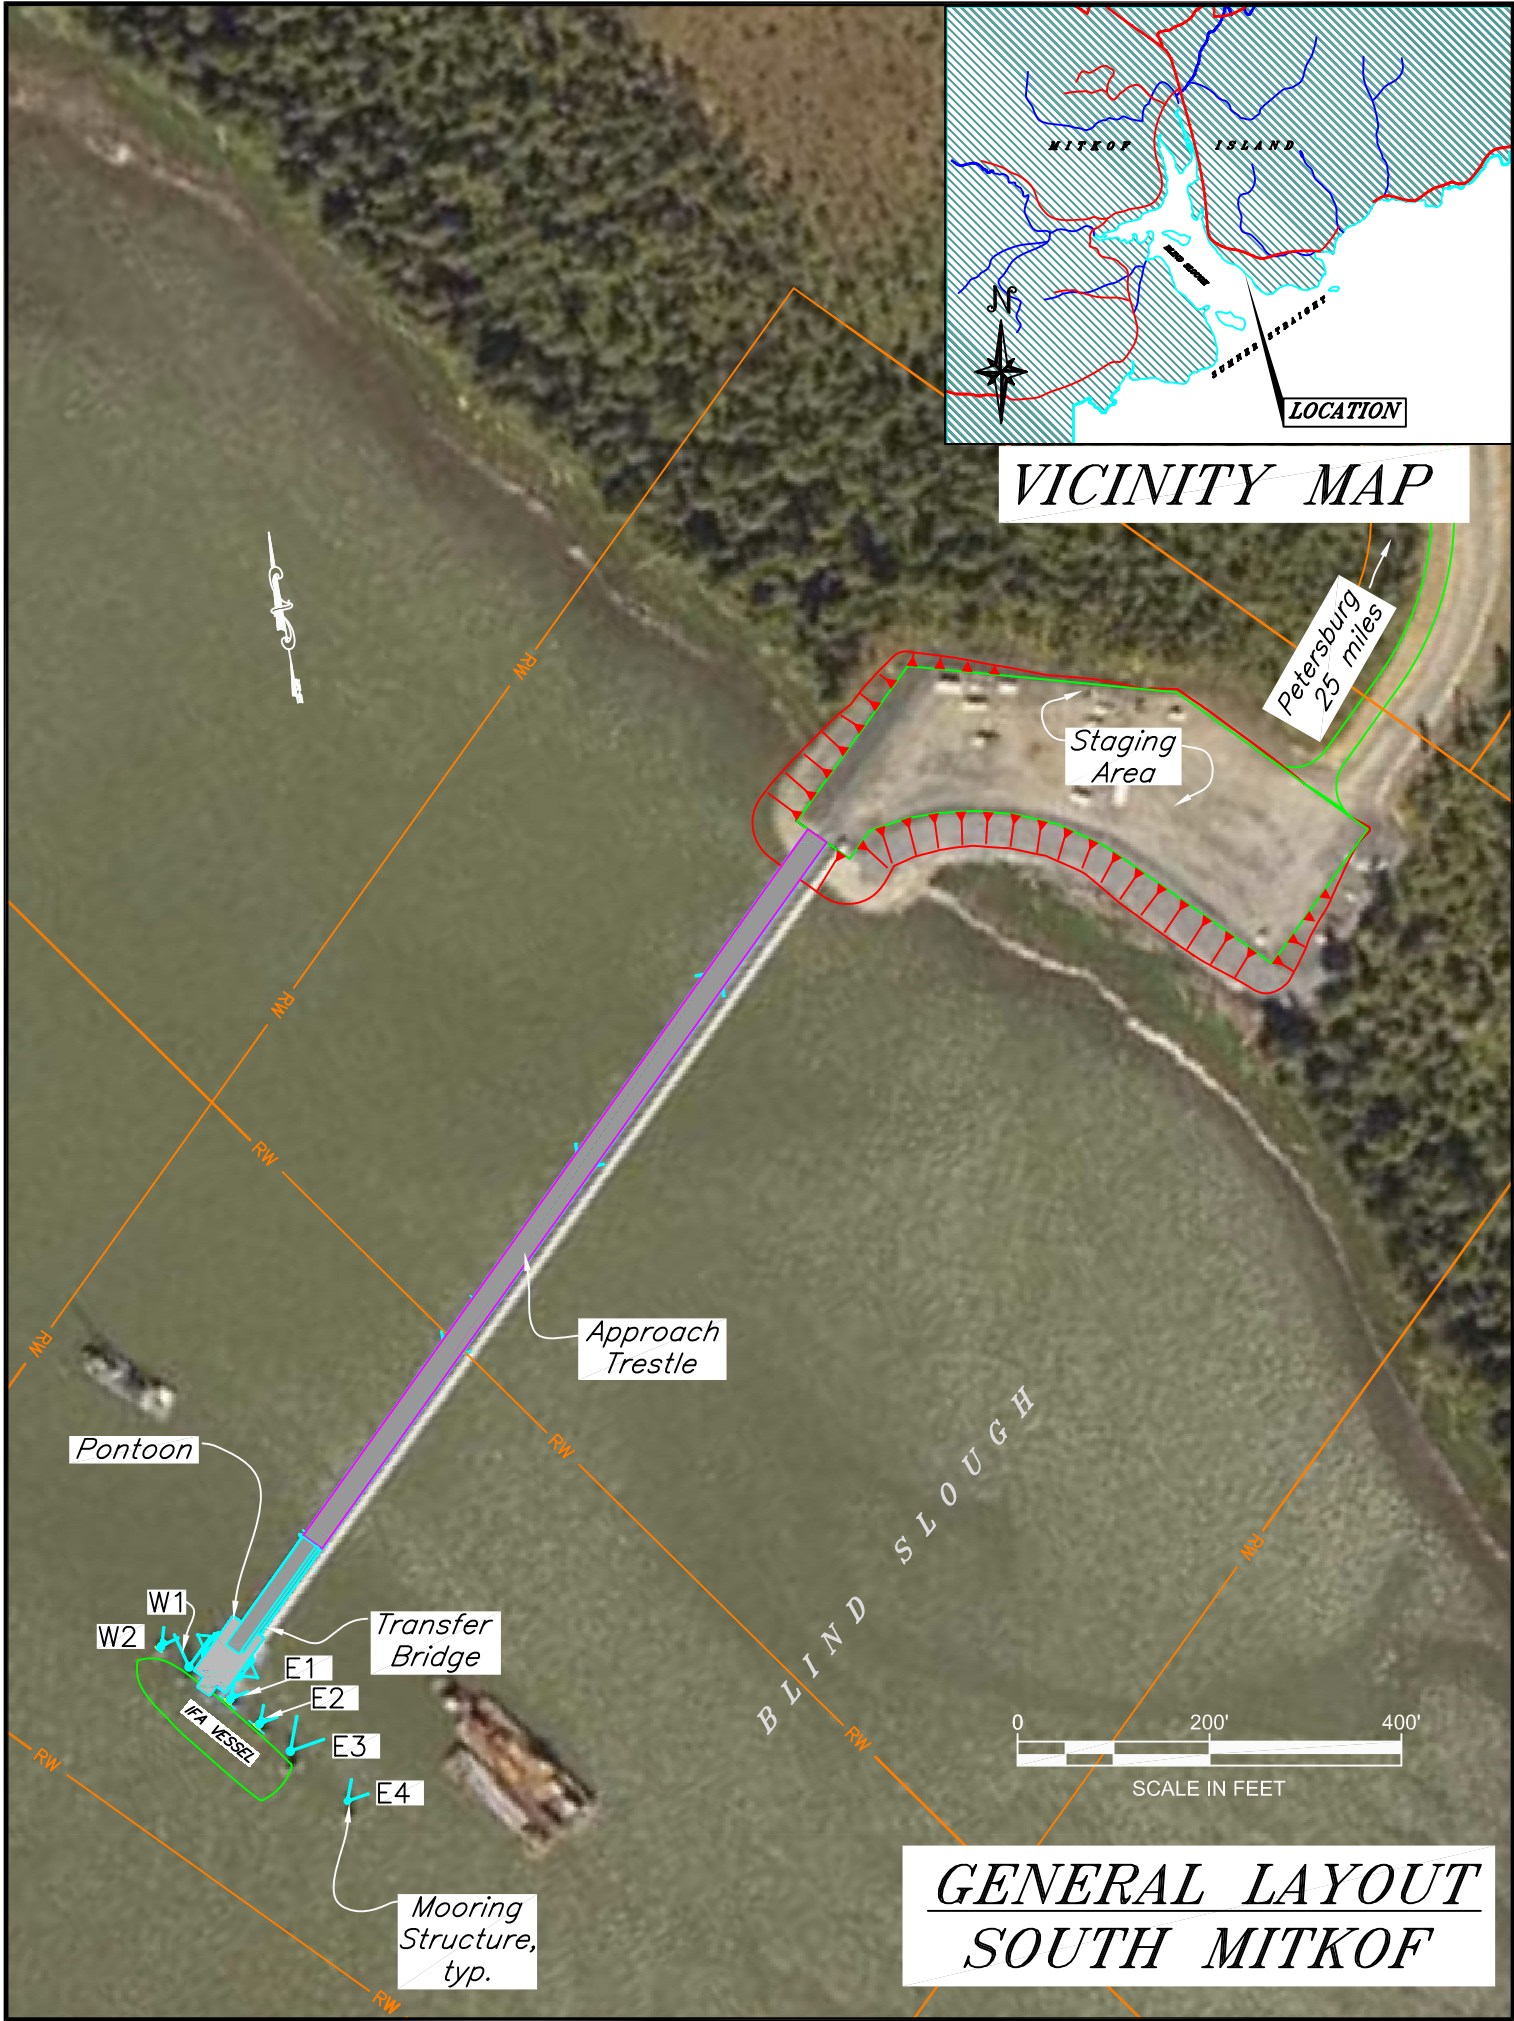
Staging
Area

Approach
Trestle

Pontoon

Transfer
Bridge

IFA VESSEL

Mooring
Structure,
typ.
